# **INDOOR AIR QUALITY ASSESSMENT**

**MassHealth  
200 Theodore Rice Blvd  
New Bedford, Massachusetts**

Prepared by:  
Massachusetts Department of Public Health  
Bureau of Environmental Health  
Indoor Air Quality Program  
November 2016

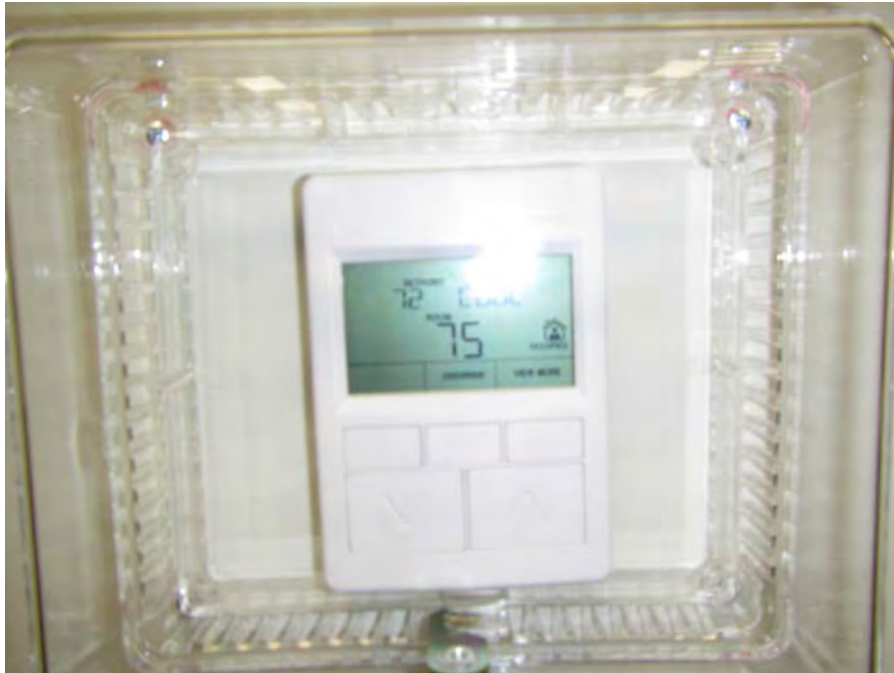
**Picture 1**

Heating, ventilation and air conditioning (HVAC) is provided by rooftop air-handling units (AHUs) ducted to supply and return vents. Conditioned air is delivered to occupied areas via louvered supply vents, and stale air is removed via ducted exhaust vents. Some larger areas also had plenum return vents. At the time of assessment, the HVAC system was operating. It should be noted that that thermostat fan settings were set to “auto” throughout the building. The thermostat in the scanning room was set to override (Picture 1); however, no air movement was detected. Thermostats should be set to “on” to provide for continuous air filtration and circulation throughout the space. Lack of air exchange/circulation can lead to the build-up of naturally occurring pollutants in the space, which can result in IAQ/comfort complaints.

**Thermostat in scanning room set to override**

1. Operate supply and exhaust ventilation continuously in all areas during occupied periods. Ensure all HVAC equipment is maintained and supply and return vents are cleaned periodically to prevent dust re-aerosolization.
2. Ensure thermostats are programmed to allow fan “on” when the building is occupied.
3. Ensure adequate ventilation in the scanner room to prevent accumulation of normally-occurring IAQ pollutants and provide occupants with a comfortable work environment.

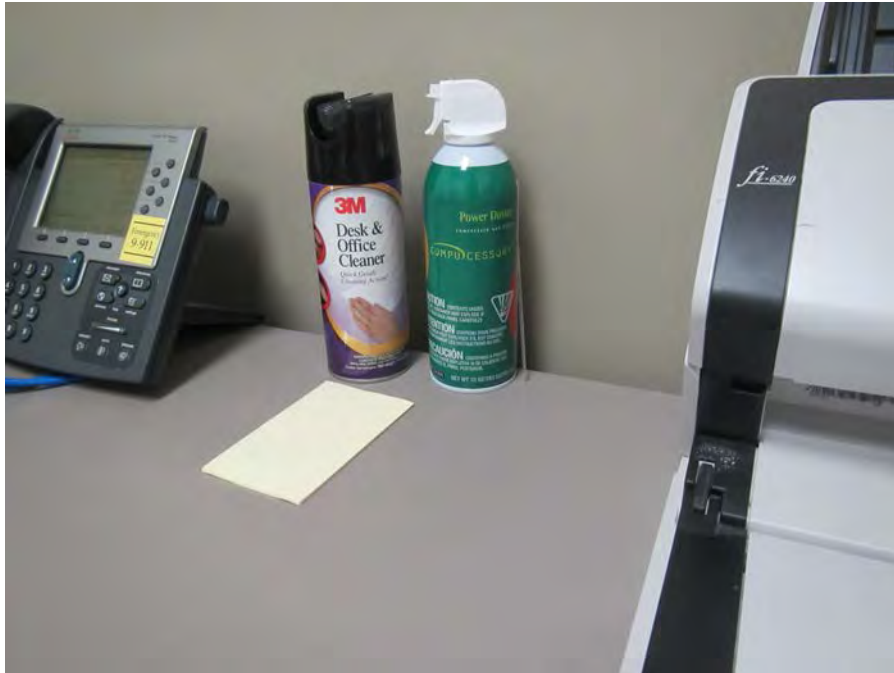
**Picture 3**

Exposure to low levels of TVOCs may produce eye, nose, throat, and/or respiratory irritation in some sensitive individuals. In addition to testing, BEH/IAQ staff examined spaces for products containing VOCs. BEH/IAQ staff noted air fresheners, hand sanitizers, cleaning products, and dry erase materials in a number of areas throughout the office space (Table 1; Picture 3). All of these products have the potential to be irritants to the eyes, nose, throat, and respiratory system of sensitive individuals.

**Cleaning products that are irritating to the eyes and respiratory system**

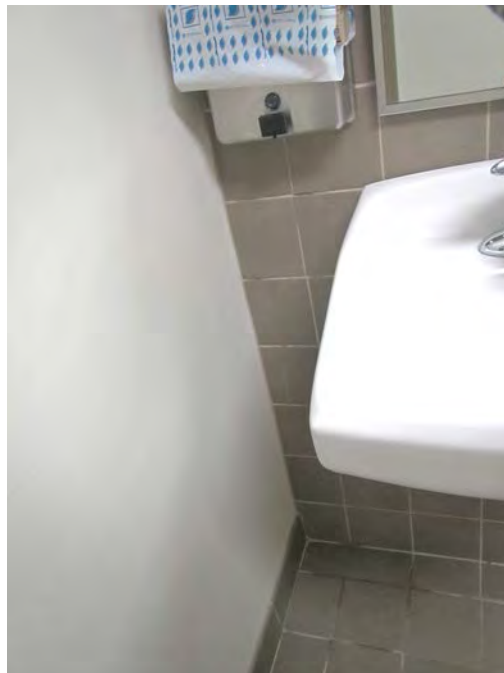
**Picture 4**

Floor and wall tile appeared stained in the bathroom due to soap dripping from the dispenser (Picture 4). Measures should be taken to prevent soap from collecting on tiles.

**Stained floor tiles from soap dispenser**
